## Magnetic Resonance Imaging (MRI)

The following section applies to the SYNCHRONY cochlear implant only. It does not apply to the SYNCHRONY ABI auditory brainstem implant

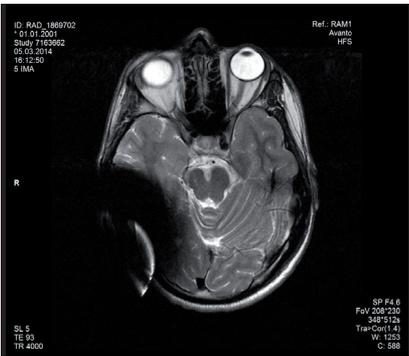
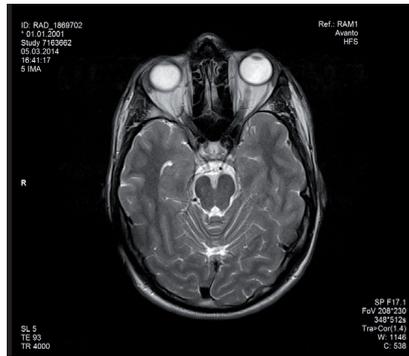
Fig. B Image artefacts arising in a 1.5T scanner. The left picture shows the artefacts obtained with the implant magnet in place whereas the right picture illustrates the image artefacts when the implant magnet is replaced with the Non-Magnetic Spacer.

- The magnet can be removed by pushing on the top side of the magnet so that it comes out at the bottom side of the implant to reduce image artefacts. If the magnet is not removed, image artefacts are to be expected (refer to Fig. B and Fig. C).
- The exchange of the magnets with the Non-Magnetic Spacer and vice versa has been tested for at least five repetitions.
- The above instructions should also be followed if areas of the body other than the head are to be examined (e.g. knee, etc.). When lower extremities are to be examined, it is recommended that the patient's legs are positioned in the scanner first.

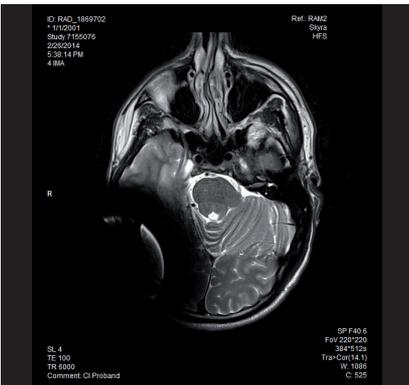
Fig. C Image artefacts arising in a 3.0T scanner. The left picture shows the artefacts obtained with the implant magnet in place whereas the right picture illustrates the image artefacts when the implant magnet is replaced with the Non-Magnetic Spacer.
